Safety Inspection Report

Operational Inspection

Corner Of New Street & School Street

Oakthorpe, Donisthorpe & Acresford Parish Council

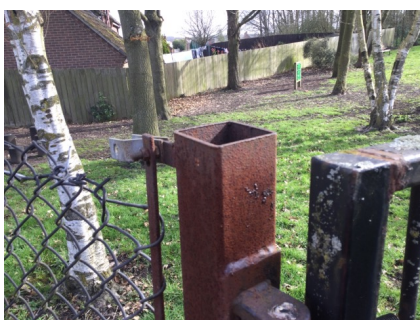
Cap missing.

Cap/s missing allowing water ingress and access to fittings. Replace.

Replace.

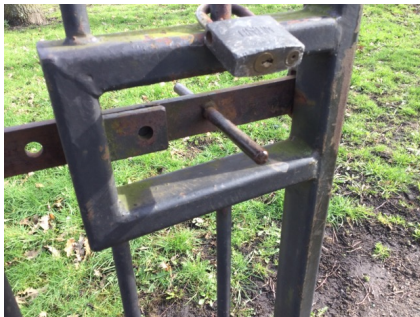
Hard or sharp projections.

Sharp edges on latch.

Remove hard, pointed and sharp projections.

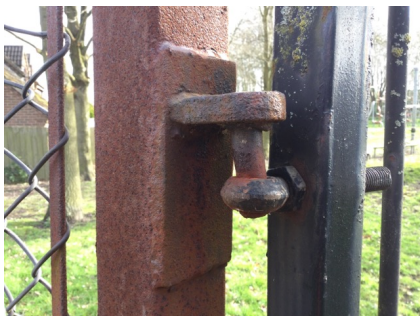
Brackets cracking and bending. Monitor gate hinge post and replace when necessary.

Monitor.

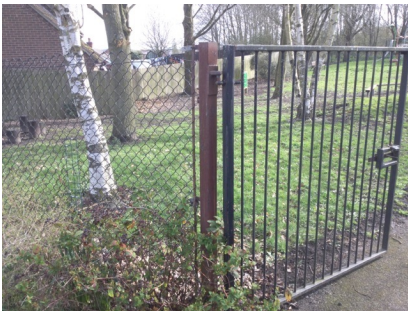
There is significant corrosion on this item.

Located on both of the gate posts.

De-scale back to good metal and coat with lead free paint, using appropriate precautions. Repairs may be necessary where corrosion is severe.

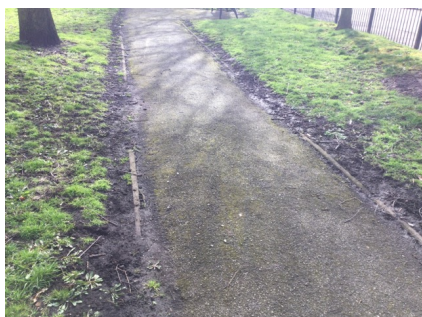
Algae growth giving slippery conditions.

Surface is algae and moss covered, providing a slippery surface when wet.

Powerwashing is recommended. Care should be taken to ensure that the material can sustain high pressure washing.

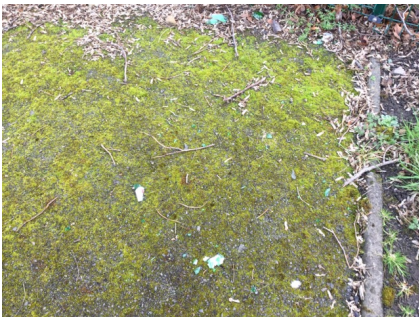
There is broken glass on site.

Located around swings pathway.

Clear away immediately.

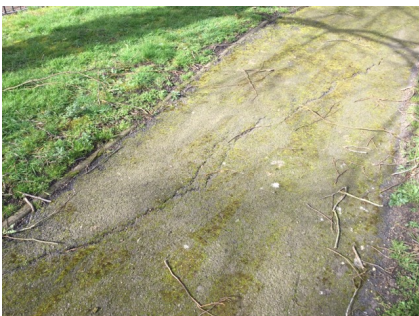
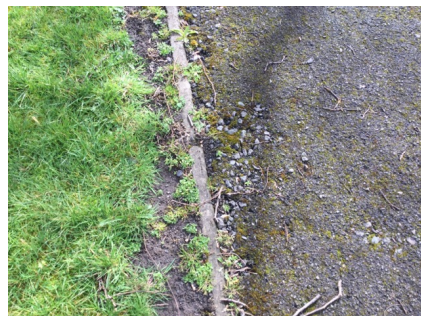
The surface is cracking.

Cracking in several areas due to tree roots underneath. Repair.
Edges are crumbling around swings. Repair.

Repair.

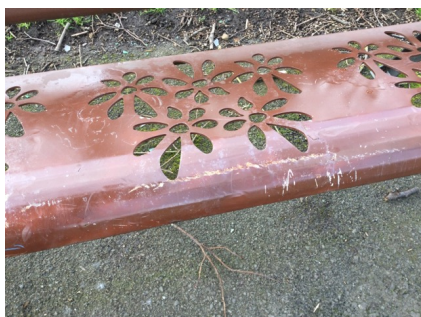
Paintwork is in poor condition.

Bench adjacent to shelter. Paint is starting to crumble.

De-scale back to good base material and coat with lead free paint, using appropriate precautions. Repairs may be necessary where corrosion is severe.

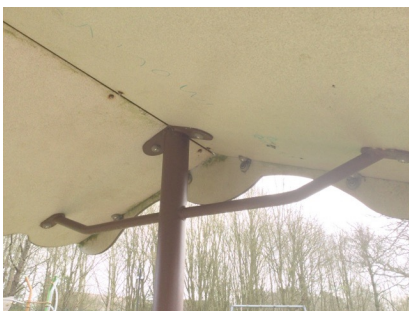
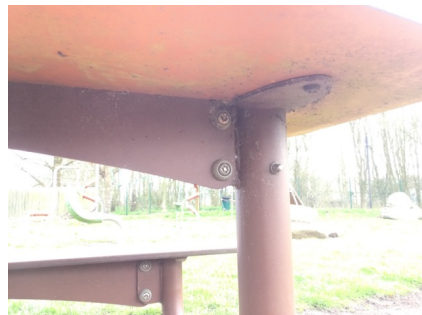
Bolt(s) loose.

Metal support post is loose to the picnic table framework. Tighten.

Tighten.

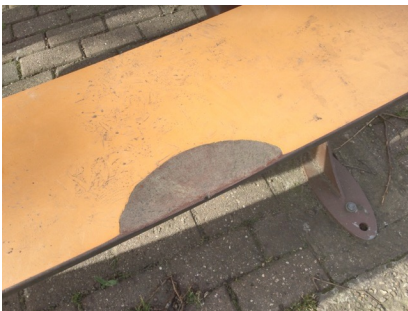
Item is damaged.

Seat board is damaged. Repair and repaint.

Repair.

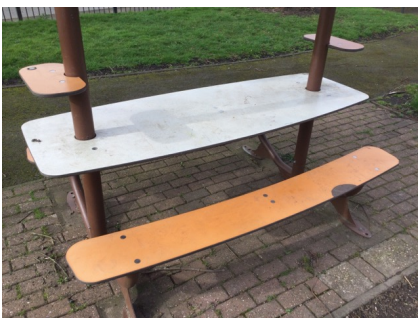
The equipment is dirty or algae covered.

Clean off.

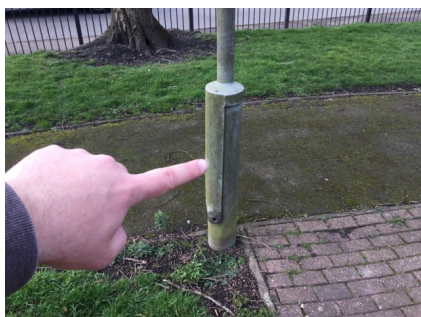
Bolt(s) loose.

Lamppost framework is becoming loose to the foundation post, allowing excess movement of the lamppost.

Tighten.

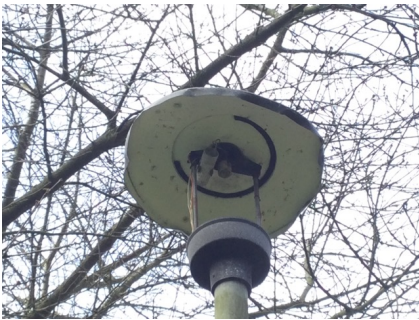
Item is damaged.

Top light fitting is damaged leaving exposed wires. Repair.

Repair.

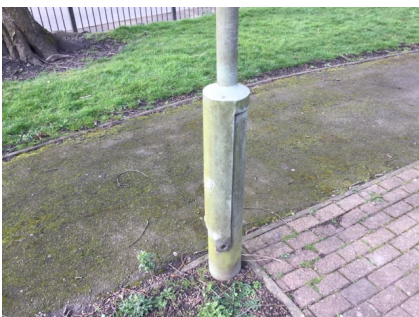
The equipment is dirty or algae covered.

Lamp post is full of algae.

Clean off.

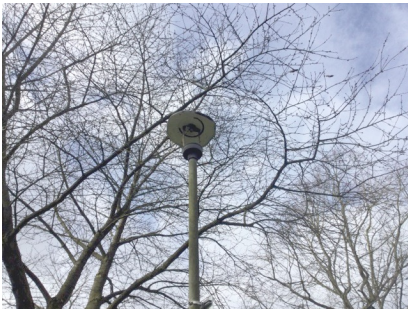
Encroaching vegetation or trees.

Cut back trees and branches.

Remove.

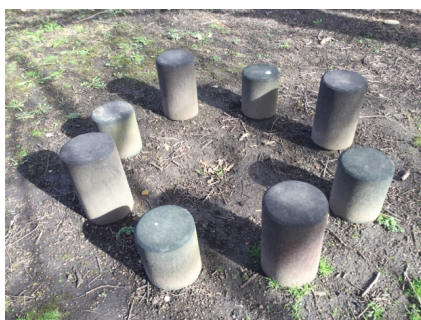
Ground erosion present.

Ground erosion is present exposing tree roots.

Repair the worn areas.

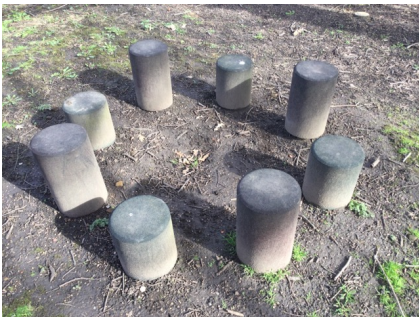
Loose in ground.

All stepping pods are loose in the ground. Re-set.

Reset.

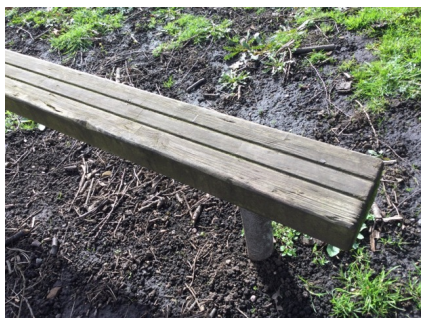
Timber is splintered.

Smooth off all splintered edges.

Repair.

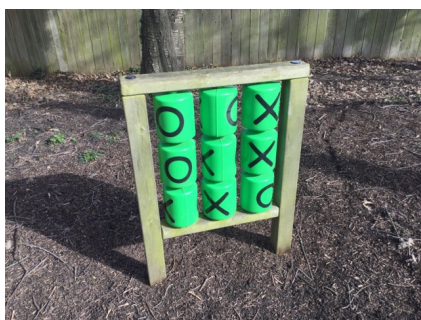
Loose in ground.

Both support posts are loose in the ground. Monitor and reset if necessary.

Read the notes for further action.

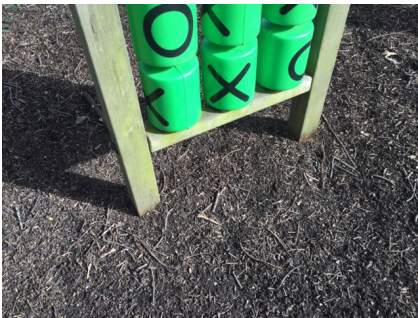
Timbers are installed into bark chip. Decomposing bark is acidic and can neutralise the alkaline timber treatment agent. This will lead to the timber decaying and failure or collapse of the equipment.

Monitor both supports for decay at ground level due to being installed in bark and softening.

Consider replacing the bark with a synthetic surface or closely monitor the timbers at ground level for decay throughout the year.

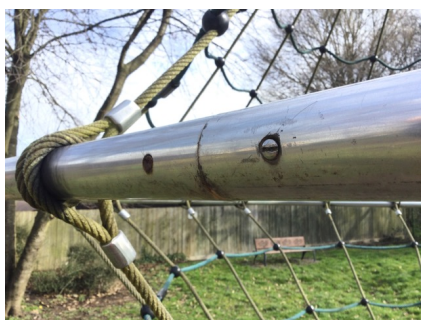
Bolt(s) loose.

Mid section beam bolt is becoming loose and projecting. Tighten.

Tighten.

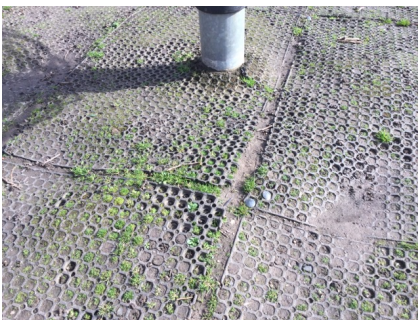
Trip points on the surface.

Trip points around rota web due to uneven surface and grass mats lifting. Repair and secure.

Repair., Read the notes for further action.

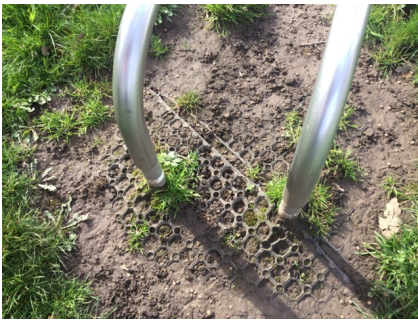
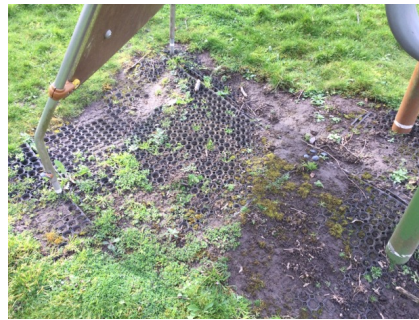
Surface needs repair.

Our inspector recommends adding additional cable ties and pegs to the grass mats to further secure the mats together.
Surface is uneven around the equipment. Build up ground levels.

Read the notes for further action.

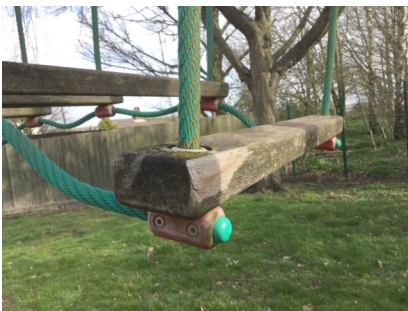
Timber is splintered.

Timber bridge slats are slightly splintered. Smooth off.

Repair.

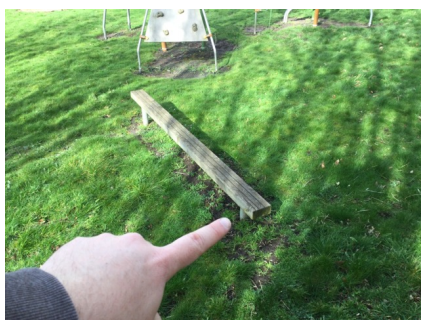
Loose in ground.

Metal support x 1 is slightly loose in the ground. Re-set.

Reset.

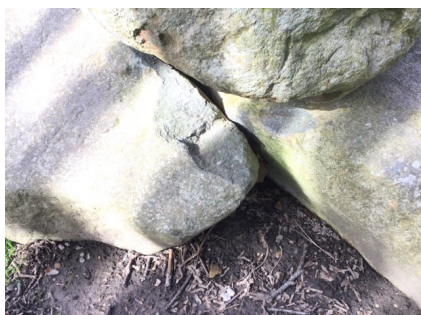
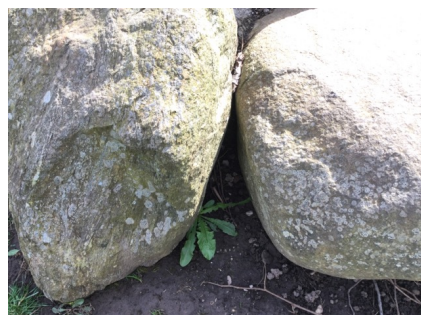
Potential foot / leg entrapment between the boulder gaps on both sets of boulders. Monitor when in use and adapt if necessary.

Monitor.

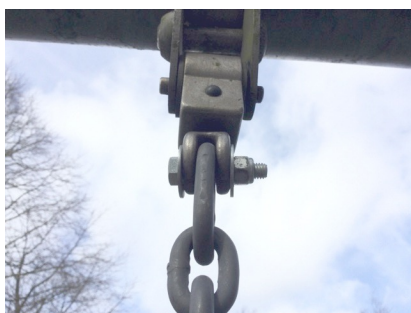
Projecting bolt thread.

Cut back unused bolt threads and install caps. Shackle through bolts.

Cut off and file down to remove sharp edges or use the correct length of bolt.

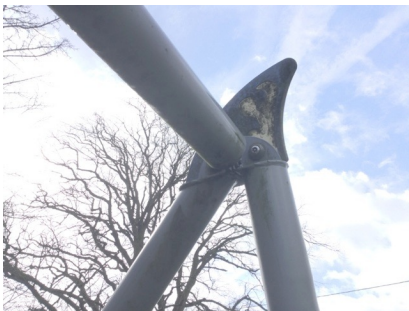
The equipment is dirty or algae covered.

Clean algae / moss off area on a regular basis due to overhead trees.

Clean off.

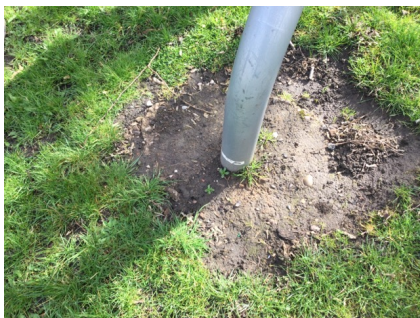
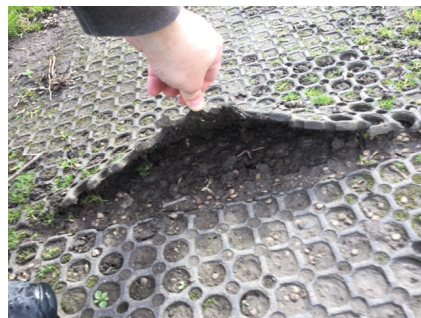
Surface needs repair.

Grass mats are lifting and separating creating a potential trip hazard. Tie down and secure. Install some more top soil over support to further cover the foundations.

Repair., Read the notes for further action.
