**Arboricultural Report:
Oakthorpe, Donisthorpe and Acresford Parish Council – Follow up inspection
of Lime tree 2 at Donisthorpe Memorial Park and Playing Fields**

Document reference: 636-22, Revision 0

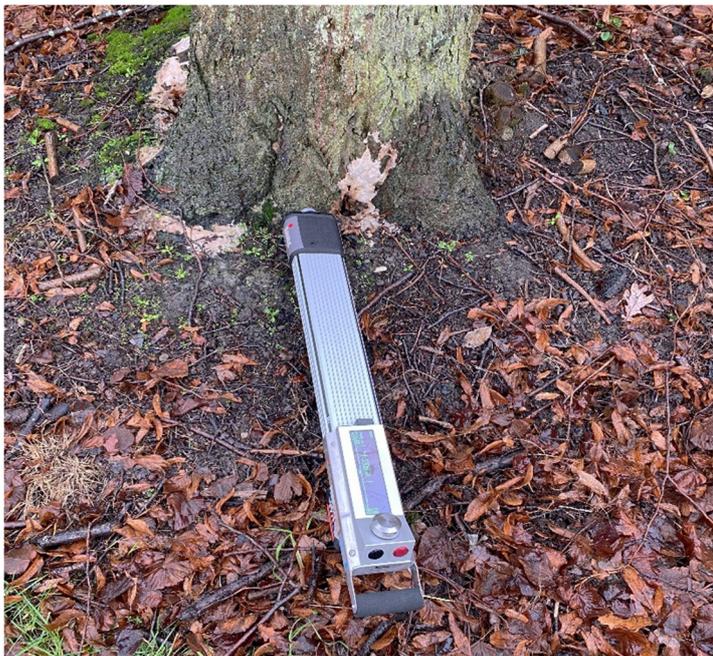
Photograph 1: Showing the base of the lime tree and the resistograph.

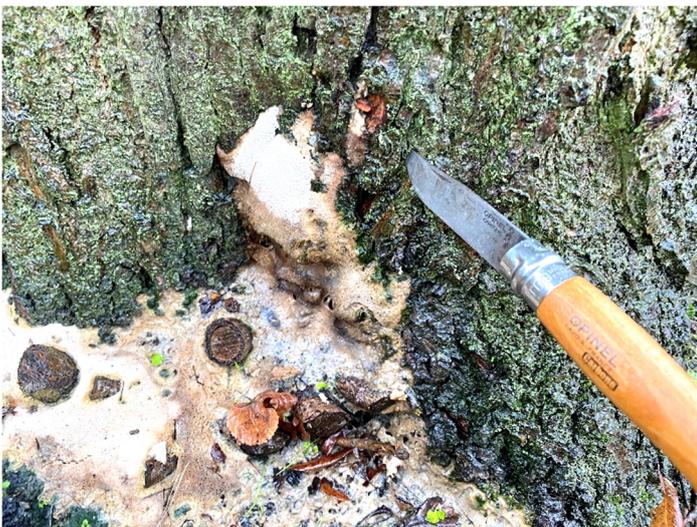
Photograph 2: Embryonic fungal growth at base of tree.

- 2.2 Although the fungal growth remained immature, preventing identification on the basis of visual characteristics, it is not consistent with the early-stage growth of the principal decay fungus *Kretzschmaria deusta*.
- 2.3 Three test drillings were made at the base of the trunk. At this point, the trunk measured 610mm. The resistance graphs are reproduced on the following page.

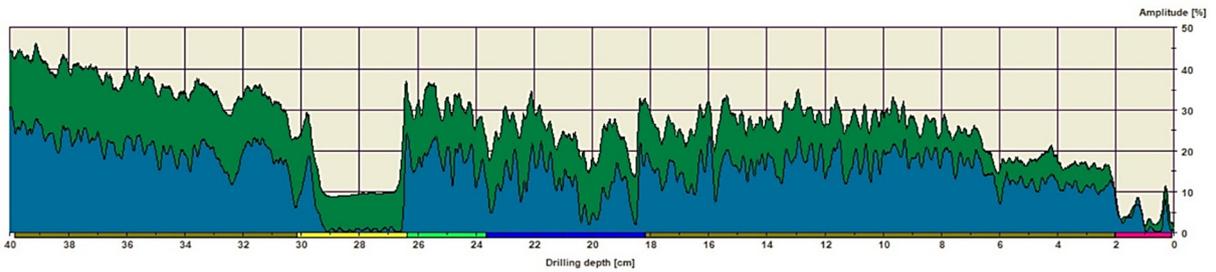
Lime 2: D1

From 0,10 cm to 2,03 cm :	Bark/Cambial Zone
From 2,03 cm to 18,19 cm :	Normal Wood
From 18,19 cm to 23,66 cm :	Incipient Decay
From 23,66 cm to 26,38 cm :	Reaction Zone
From 26,38 cm to 30,16 cm :	Decay
From 30,16 cm to 39,90 cm :	Normal Wood

- 2.4 Drilling 1 revealed a small area of advanced decay, confined within the centre of the trunk, and a modest zone of early-stage (insipient) decay between 18 and 23cm from the outside of the trunk.
- 2.5 Drilling 2 encountered the same central zone of decay, albeit less advanced. Drilling 3 showed normal wood conditions for the full depth of the testing and serves well as a comparison of normal versus decay altered wood.
- 2.6 In terms of the physiological condition of the tree, it remains fair overall. However, when compared against the contemporary lime trees nearby, the density of the growth around the perimeter of the crown is slightly reduced. There has been some initiation of new growth within the lower crown region.

- 3.1 Some decay is evident but is confined within the middle of the trunk. Currently there remains adequate residual wall thickness within the tested region of the trunk to allow the tree to be retained without the need for any crown reduction pruning.
- 3.2 At this stage, it is recommended that dead and defective branches should be removed. It is appropriate to pay particular attention to this tree during future assessments.

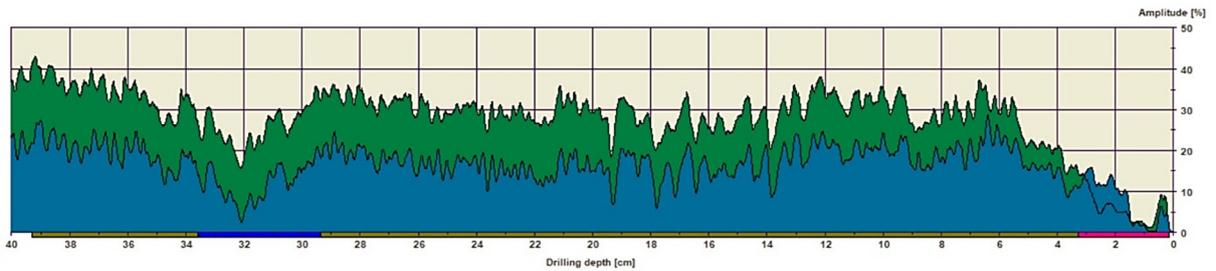
Lime 2: D2

From 0,17 cm to 3,30 cm :	Bark/Cambial Zone
From 3,30 cm to 29,37 cm :	Normal Wood
From 29,37 cm to 33,60 cm :	Incipient Decay
From 33,60 cm to 39,28 cm :	Normal Wood

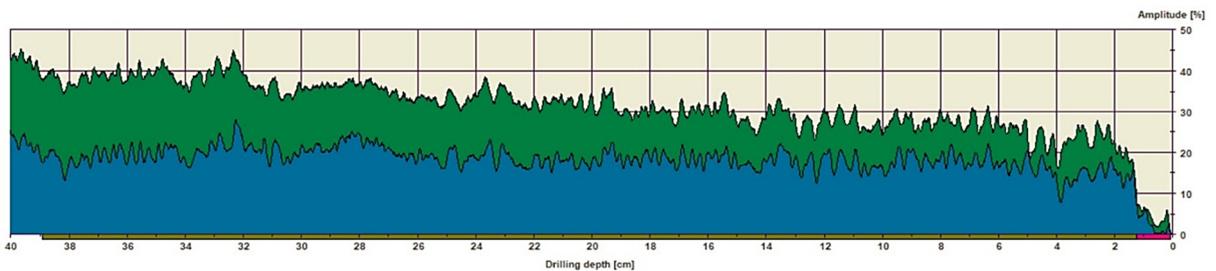
Lime 2: D3

From 0,10 cm to 1,24 cm :	Bark/Cambial Zone
From 1,24 cm to 38,93 cm :	Normal Wood

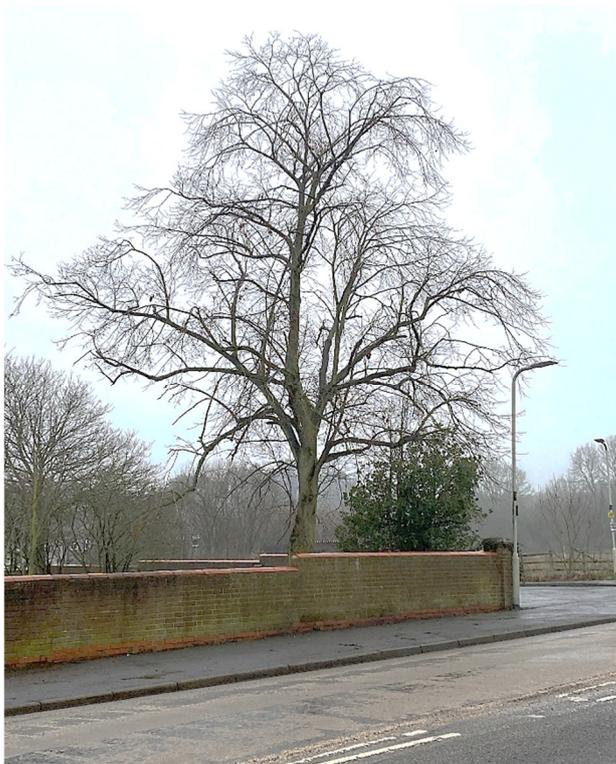
Photograph 3: Showing the crown of the tree, as viewed from the roadside.
