Safety Inspection Report

Operational Inspection

Corner Of New Street & School Street

Oakthorpe, Donisthorpe & Acresford Parish Council

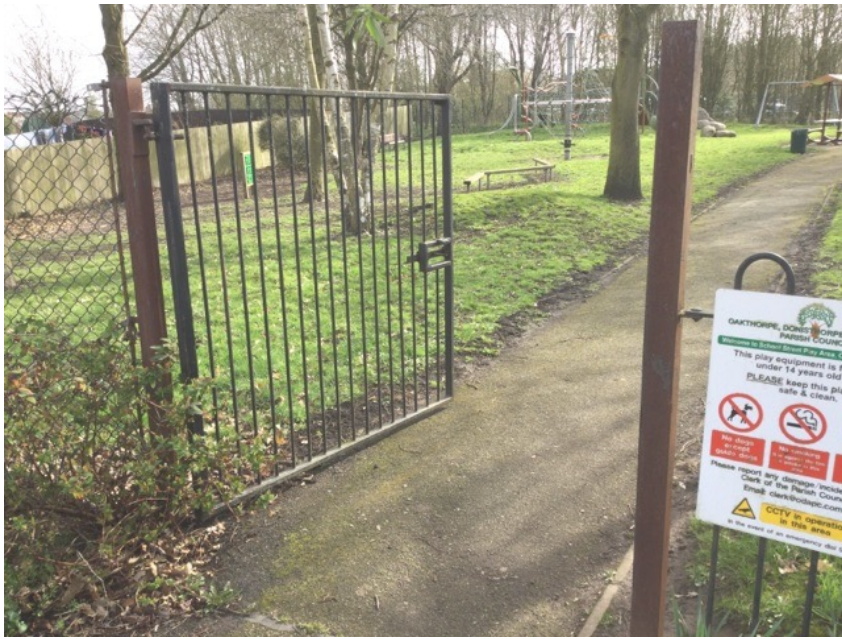
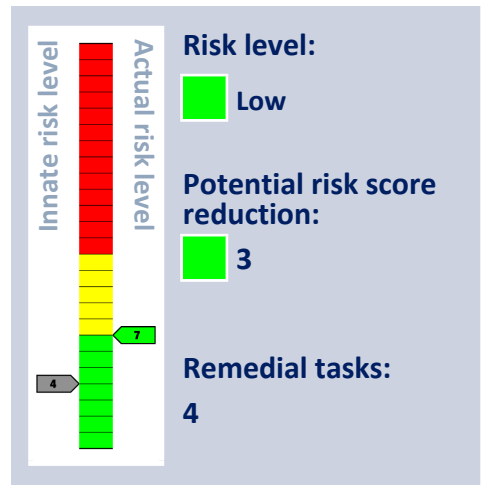
Gates

Cap missing.

Cap/s missing allowing water ingress and access to fittings. Replace.

Brackets cracking and bending. Monitor gate hinge post and replace when necessary.

Replace.

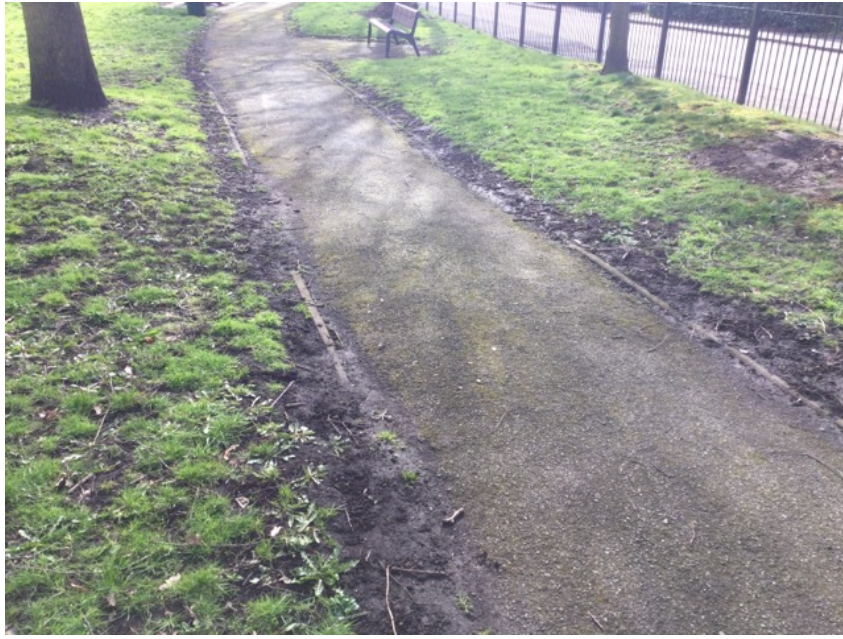
Pathways (Internal)

Algae growth giving slippery conditions.

The surface is cracking.

Cracking in several areas due to tree roots underneath. Repair.
Edges are crumbling around swings. Repair.

Powerwashing is recommended. Care should be taken to ensure that the material can sustain high pressure washing.

Repair.

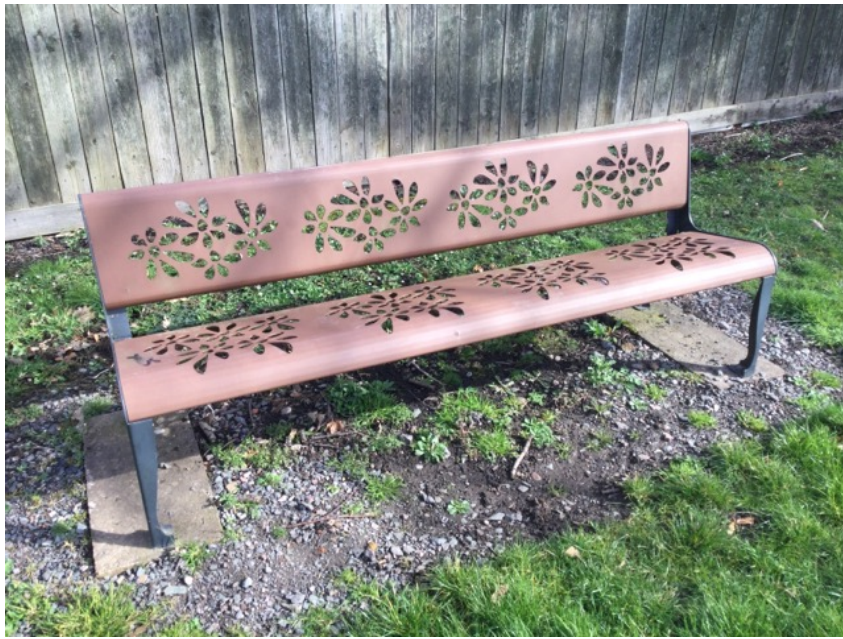
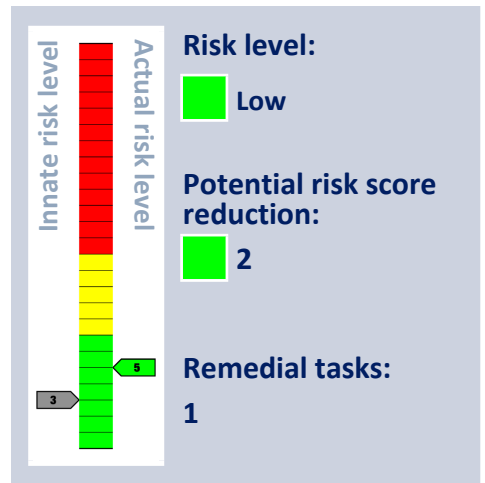
Seating

Paintwork is in poor condition.

De-scale back to good base material and coat with lead free paint, using appropriate precautions. Repairs may be necessary where corrosion is severe.

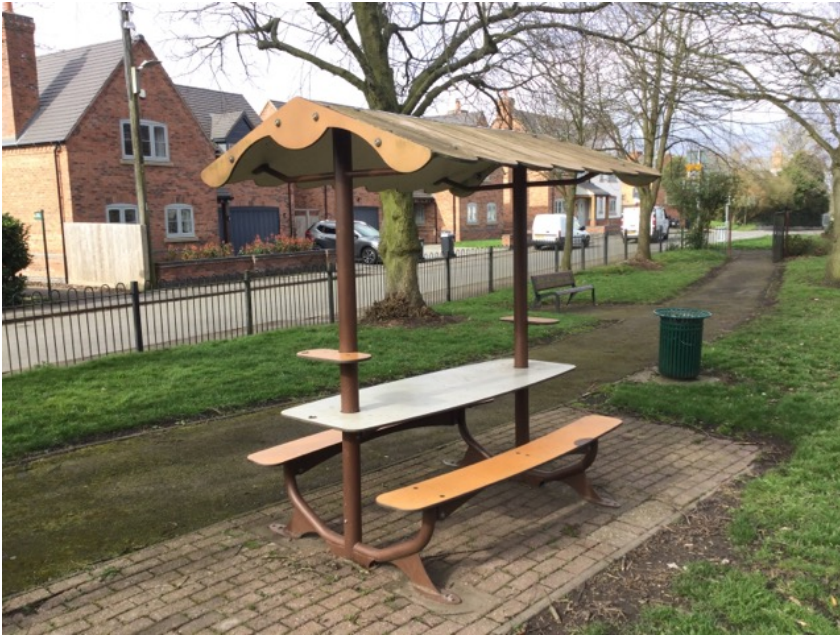
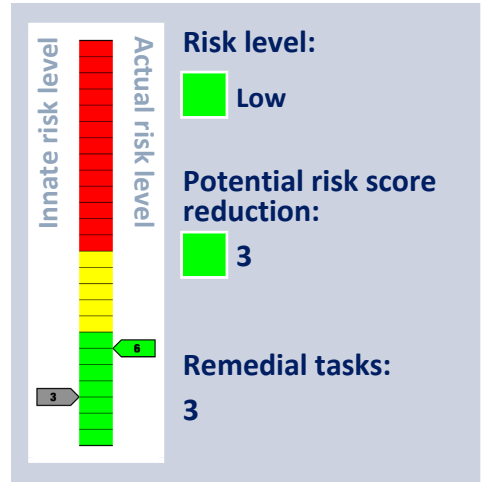
Seating - Picnic Table - Shelter

Bolt(s) loose.

Metal support post is loose to the picnic table framework. Tighten.

Item is damaged.

Seat board is damaged. Repair and repaint.

Repair.

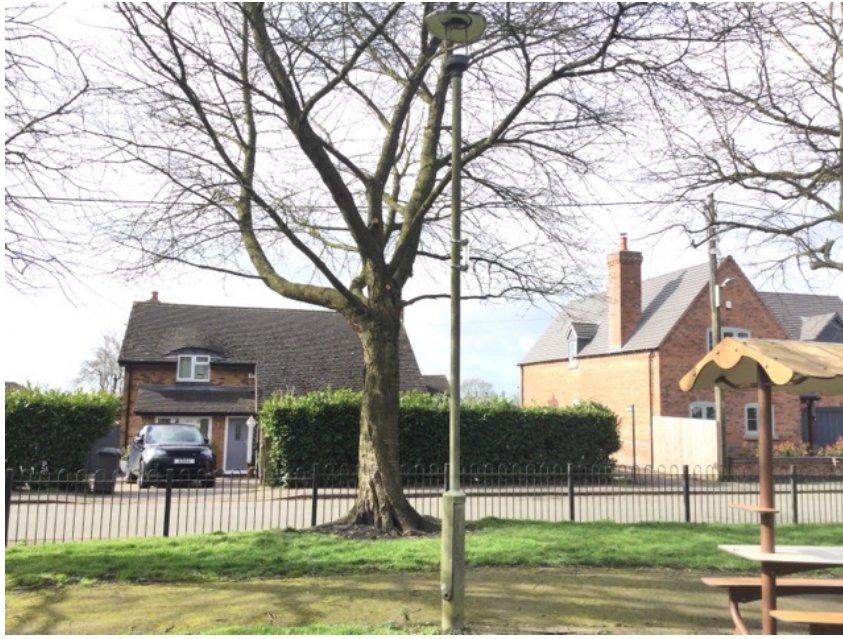
Bolt(s) loose.

Lamppost framework is becoming loose to the foundation post, allowing excess movement of the lamppost.

Item is damaged.

Top light fitting is damaged leaving exposed wires. Repair.

Repair.

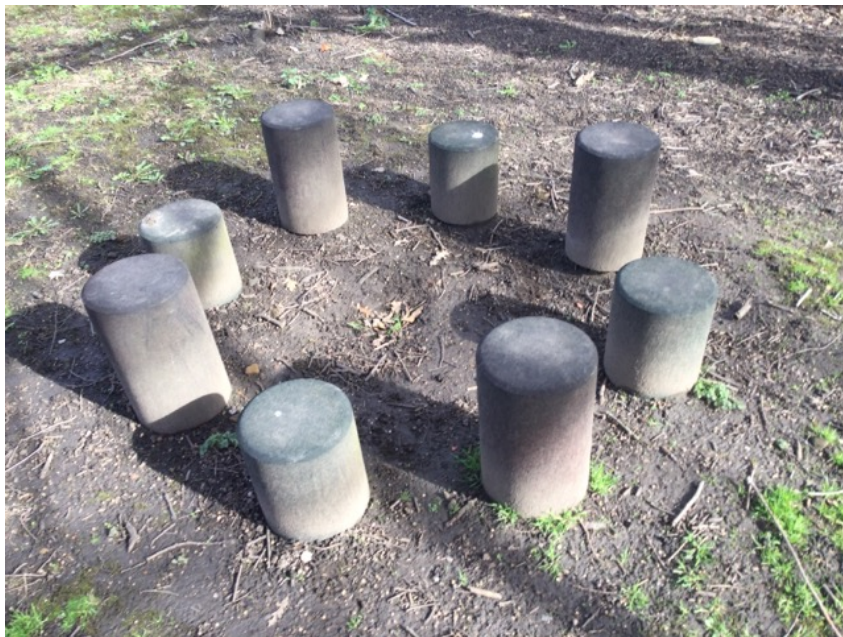
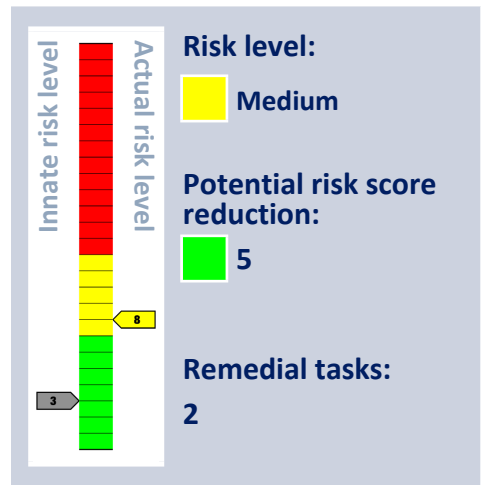
Stepping Pods

Loose in ground.

All stepping pods are loose in the ground. Re-set.

Repair the worn areas.

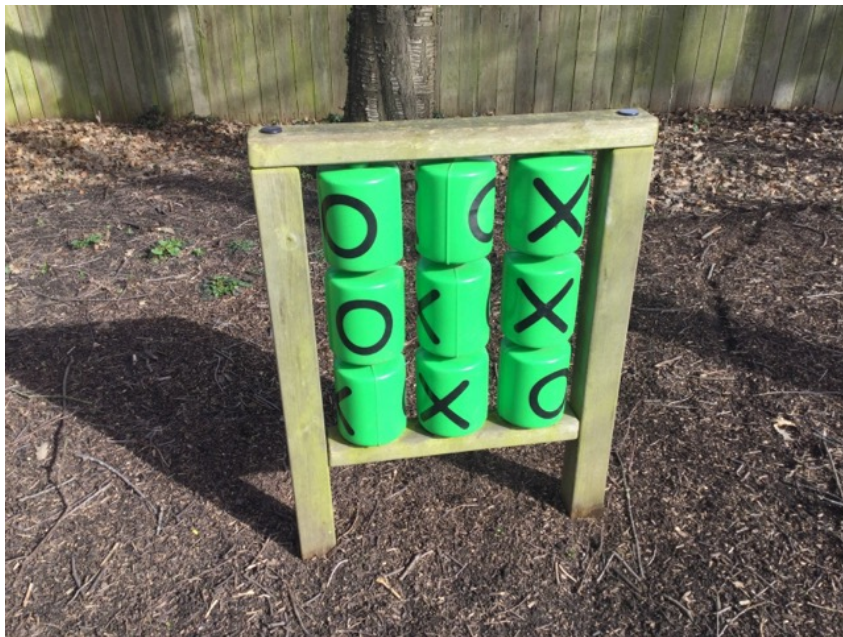
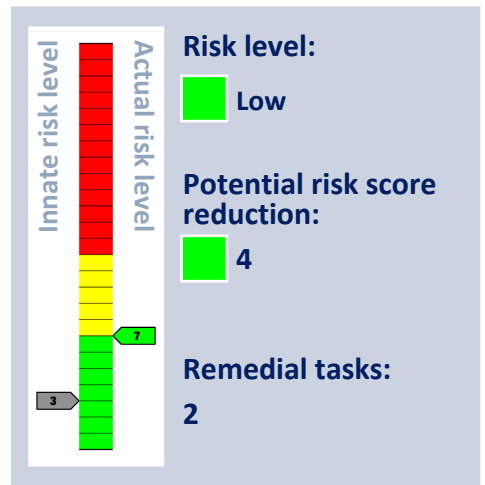
Play Panel

Loose in ground.

Both support posts are loose in the ground. Monitor and reset if necessary.

Timbers are installed into bark chip. Decomposing bark is acidic and can neutralise the alkaline timber treatment agent. This will lead to the timber decaying and failure or collapse of the equipment.

Monitor both supports for decay at ground level due to being installed in bark and softening.

Consider replacing the bark with a synthetic surface or closely monitor the timbers at ground level for decay throughout the year.

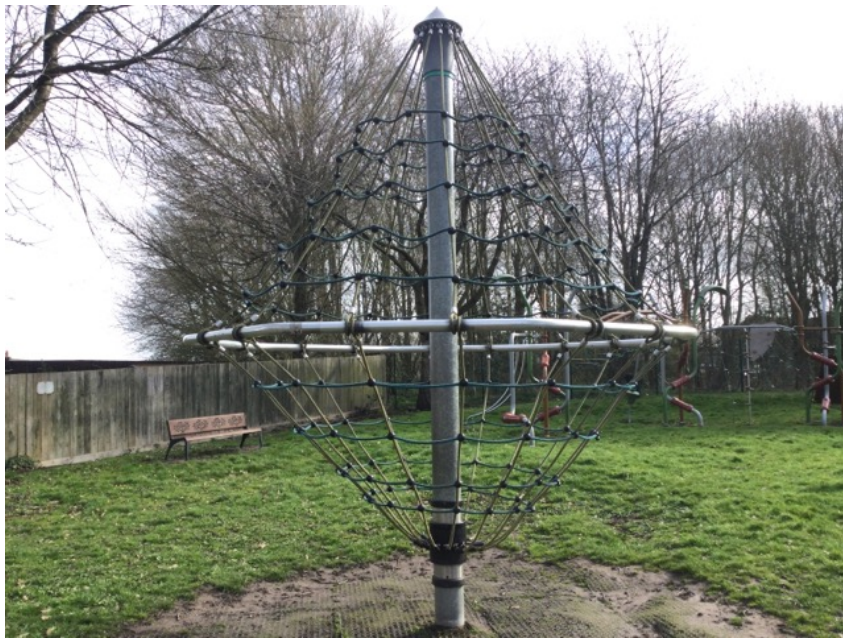
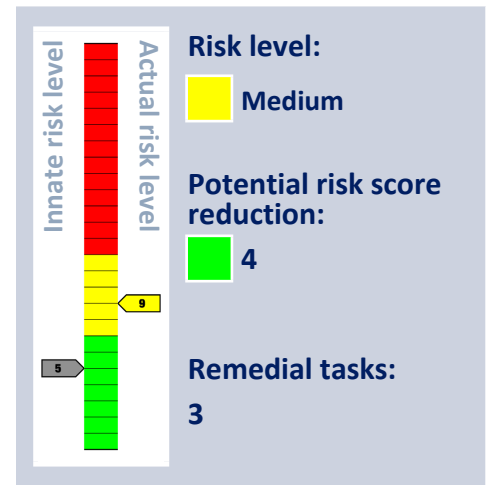
Climber - Rota Web

Bolt(s) loose.

Mid section beam bolt is becoming loose and projecting. Tighten.

Trip points around rota web due to uneven surface and grass mats lifting. Repair and secure.

Repair., Read the notes for further action.

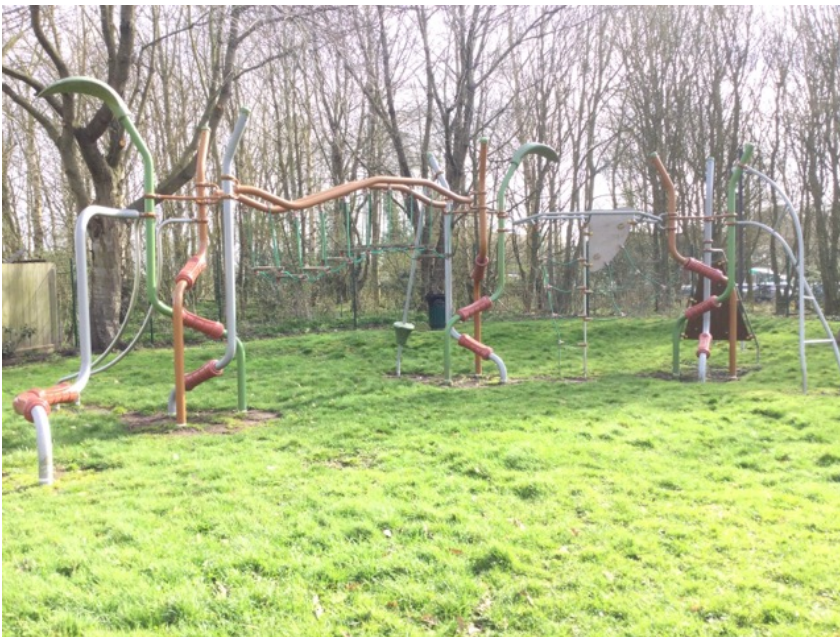
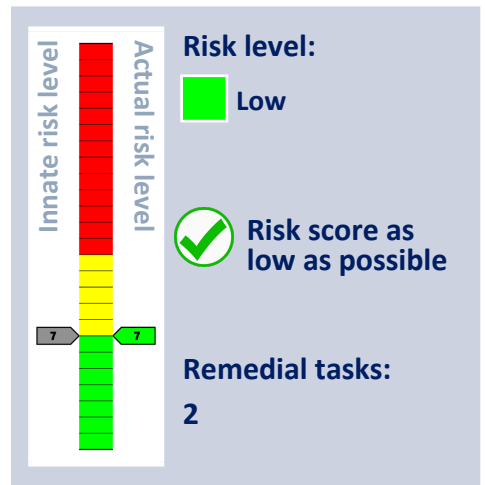
Multiplay - Climber

Surface needs repair.

Our inspector recommends adding additional cable ties and pegs to the grass mats to further secure the mats together.
Surface is uneven around the equipment. Build up ground levels.

Repair.

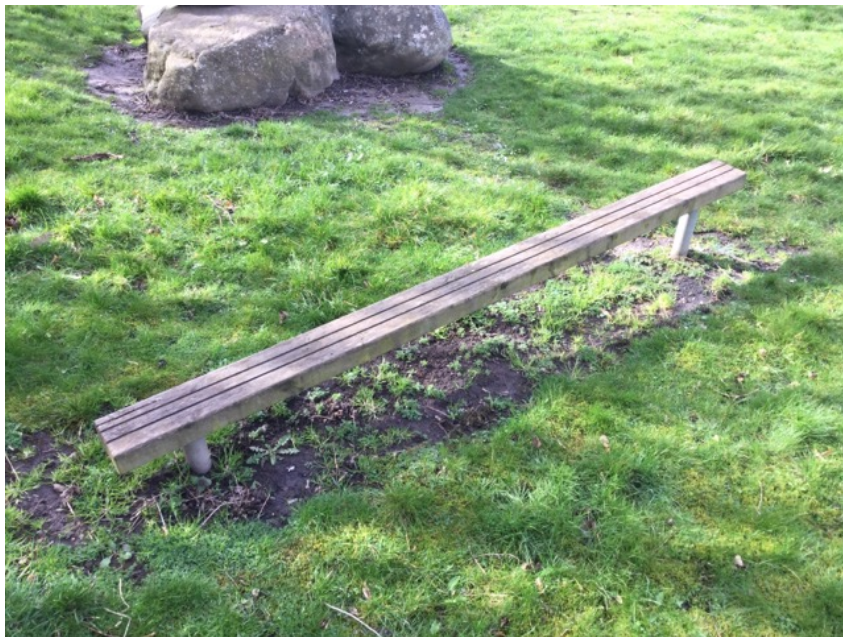
Balance Beam - Single

Loose in ground.

Metal support x 1 is slightly loose in the ground. Re-set.

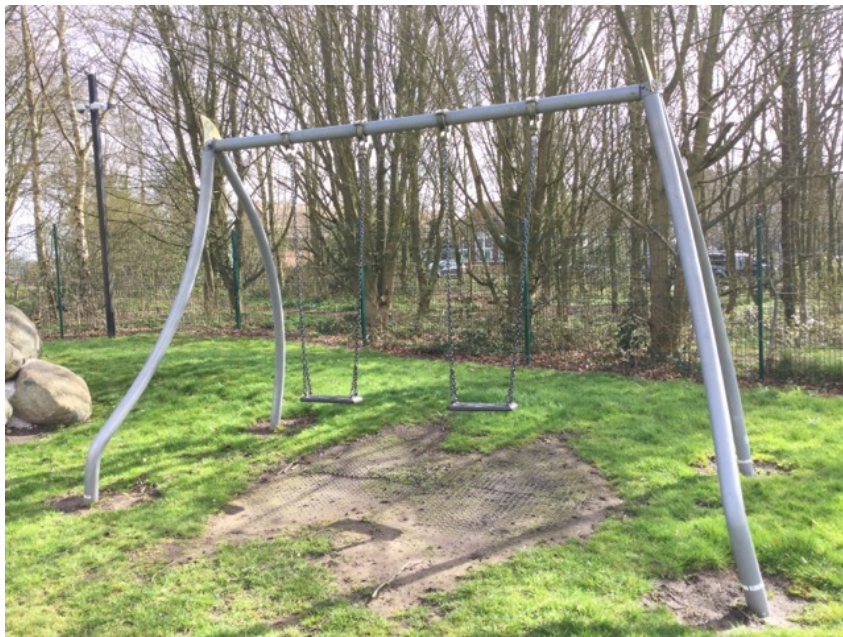
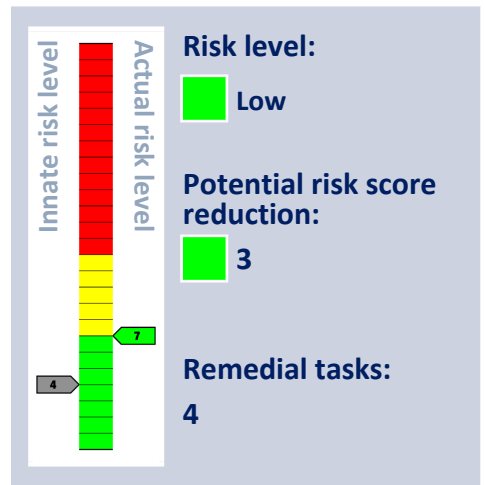
Swing - Junior - 1 Bay 2 Seat

Surface needs repair.

Grass mats are lifting and separating creating a potential trip hazard. Tie down and secure. Install some more top soil over support to further cover the foundations.

Repair., Read the notes for further action.
