**Arboricultural Report:
Oakthorpe, Donisthorpe and Acresford Parish Council – Follow up inspection
of Lime tree 2 at Donisthorpe Memorial Park and Playing Fields**

Document reference: 636-22, Revision 0

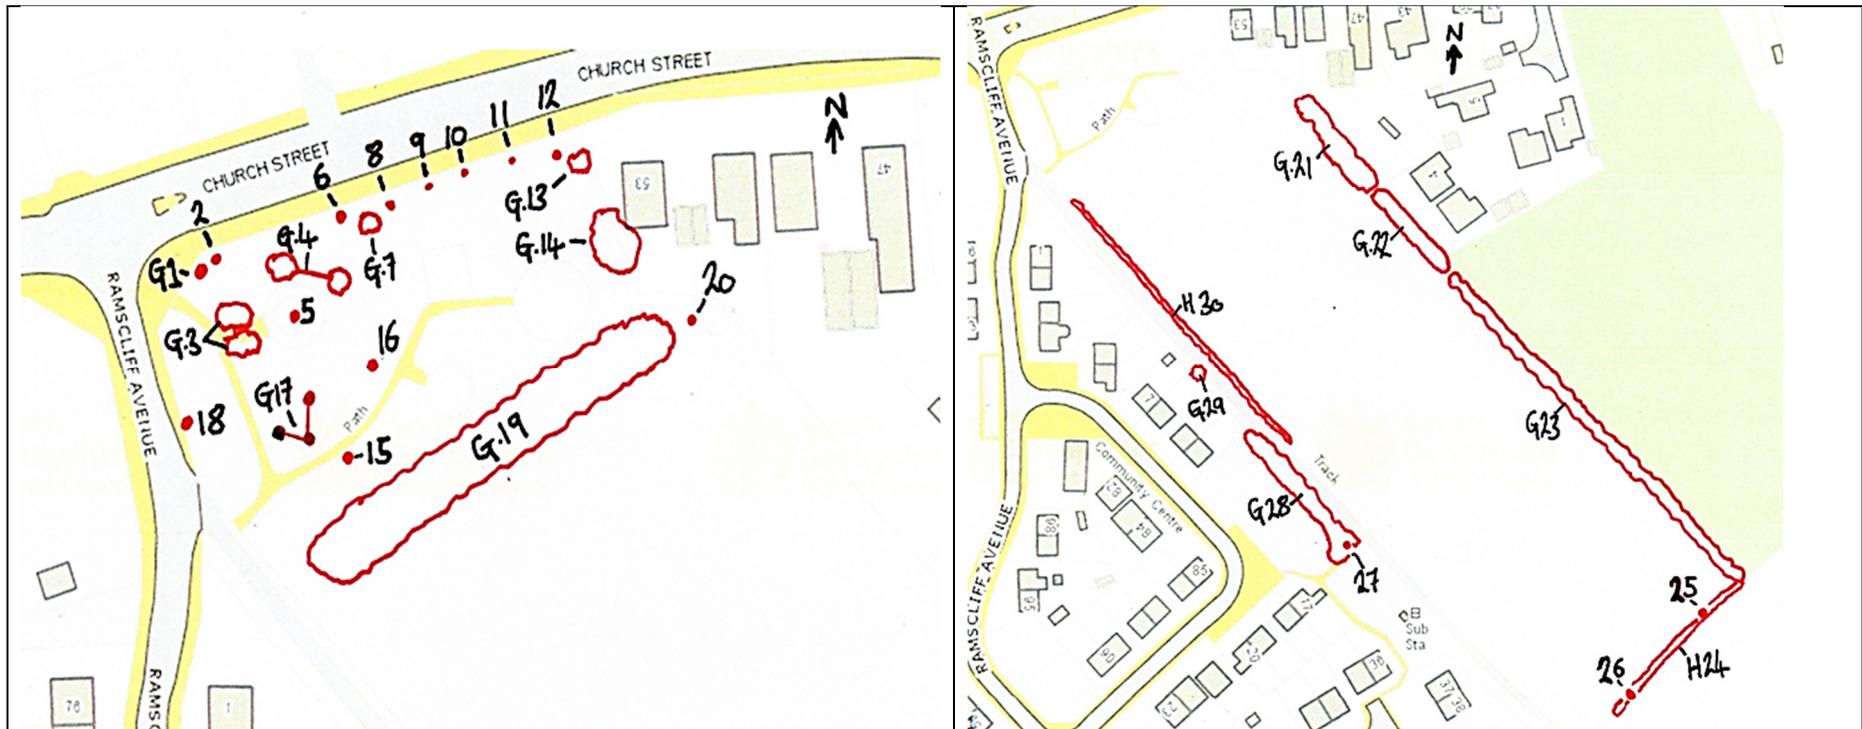
Figures 4 and 5: Sketch plans showing the approximate positions of trees surveyed at the Memorial Park and Playing Fields, Donisthorpe.

Tree number	Common name <i>Genus species</i>	Tree height (m)	Trunk diameter (cm)	Branch spread (m)	Age	Physiological condition	Structural condition	Comments and recommendations	Priority code
2	Common lime <i>Tilia x europaea</i>	11	46	5.5	EM	B/C	B/C	<p>Tree set back from frontage wall and likely a lapsed pollard.</p> <p>Extensive fungal mycelium/imperfect stage fruiting body formations around trunk base on park side. Currently, there appears to be no associated bark necrosis.</p> <p>Going by the sheer mass of the growth, it appears initially unlikely to be imperfect stage fruiting bodies of the principal decay fungus <i>Kretzschmaria deusta</i>. However, this remains a possibility.</p> <p>Crown shows slight recession and a number of dead and defective branches. However, only minimal deadwood on the public pavement side.</p> <p>Reassess trunk base in December 2021.</p> <p>If tree deemed acceptable for retention at this stage, then dead and defective branches should be removed and the tree subject to particular monitoring.</p>	1
